RARITAN RIVER BASIN

WESTONS MILLS ARCH DAM

PHASE I INSPECTION REPORT
NATIONAL DAM SAFETY PROGRAM

NJ 00382

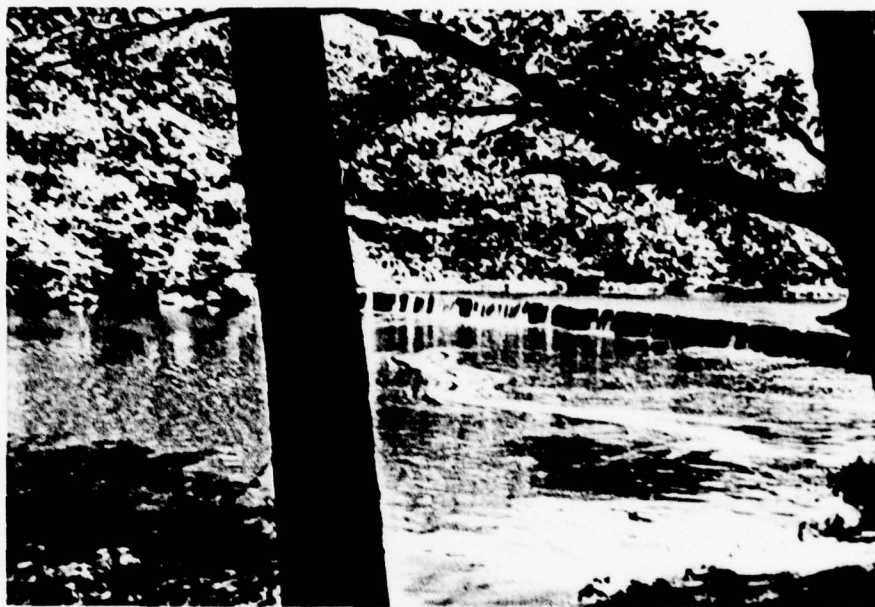
The alignment of the concrete structure is plumb and true and no significant tilting or differential settlements were observed. It is noted that the entire spillway is continuously passing several inches of water hence close visual examination is limited.

Referring to Section 2.4.b, only minor cracking and spalling were observed during the field check but because the structure is unreinforced, temperature, rib shortening and shrinkage cracks may be expected in the concrete arch. The reentrant corners of the abutments are deteriorated with the edges broken off but this is of minor consequence.

Downstream view of spillway

c. During the next period of low flow, the reservoir should be drawn down as necessary to investigate the extent of spalling and surface deterioration of the concrete. Any remedial actions found necessary, should be initiated within six months of the drawdown.

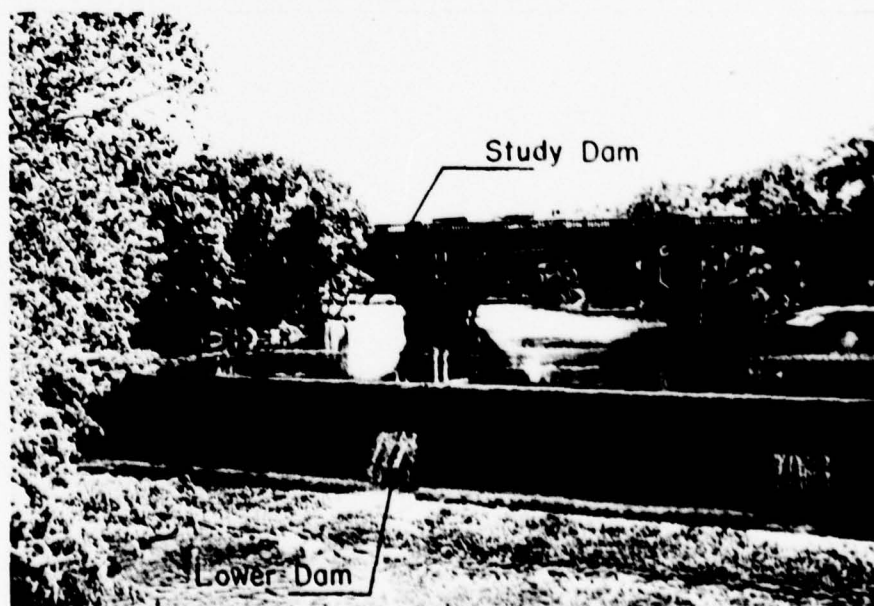
It is believed that the safety of this dam would be substantially decreased if the Lower Dam were to fail. This is due principally to the short 600 foot distance between them which maintains a tailwater on the study dam during overtopping flood conditions.

Dam downstream of study dam
